RE-CERTIFICATION : **API RP 7L CAT. IV**  
SCOPE OF WORK : **DRAWWORK components**  
MANUFACTURER : **NATIONAL**  
TYPE No : **1625-DE**  
RIG No : **RIG# 5870**  
CLIENT : **SAIPEM**  
DATE : **FEBRUARY 22<sup>TH</sup> 2019**

<b>RIG 5870 – SAIPEM, ROMANIA</b> <b>EQUIPMENT INSPECTION ON FIELD AS PER CAT III</b> <b>AND CAT IV</b>	Doc. n. IR-20190220	
		Rev. P00	Date: February 20 <sup>th</sup> 2019

## DRAWWORK , 20/02/2019 update

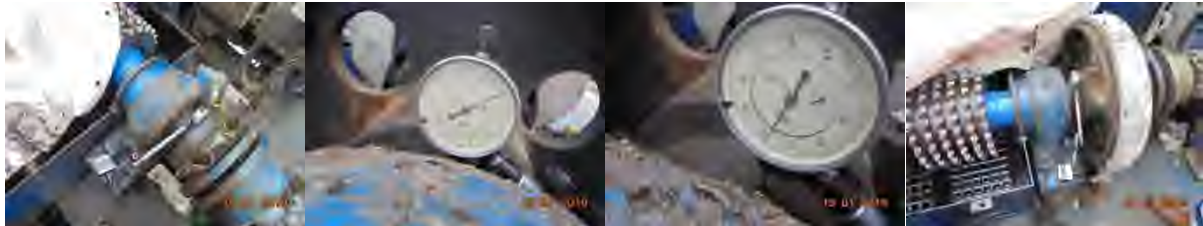
- a. Checked the bearings clearance on electric motors shaft. Clearance found in tolerance

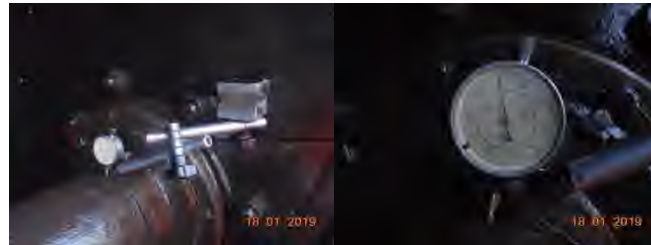
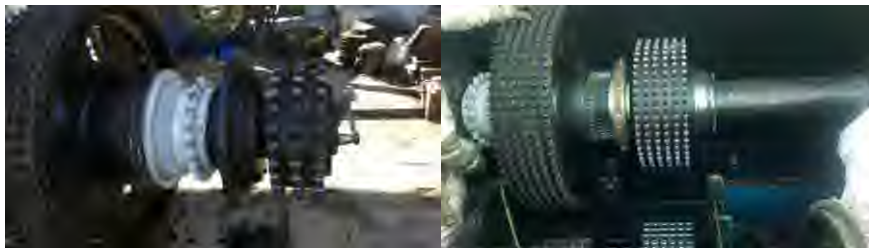
- b. Checked the bearings clearance on power input shaft. Clearance found in tolerance

Update 20/02/2019: bearing replaced with new. During point “c” correction was necessary to remove them and in the same time, new bearings were installed

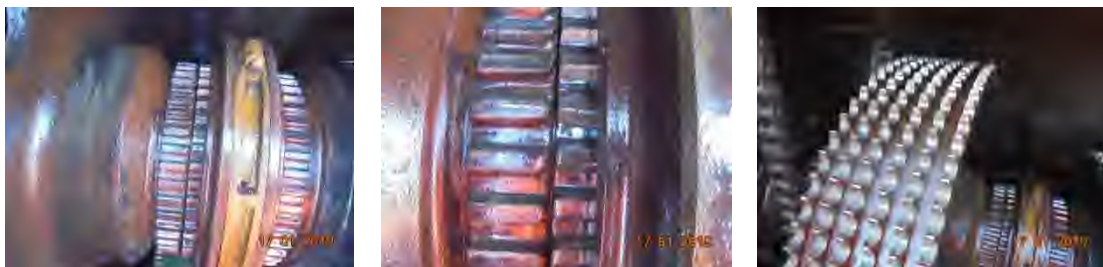
- c. Found the coupling between low gear and shaft with two (2) broken teeth. Advise to replace

Update 20/02/2019: low speed sprocket (part of it is the damaged coupling) replaced with new. Shifter also replaced with new

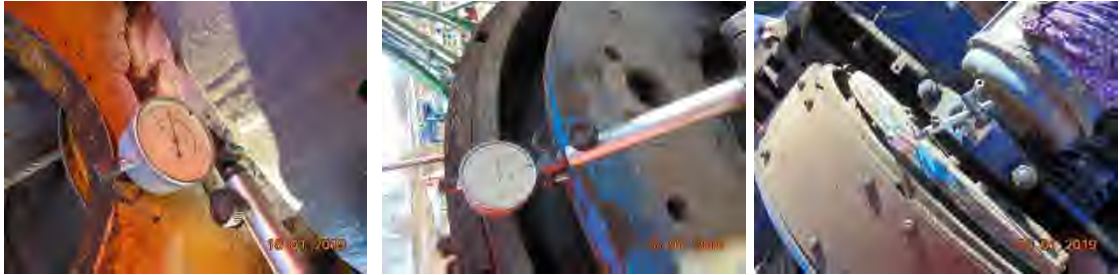
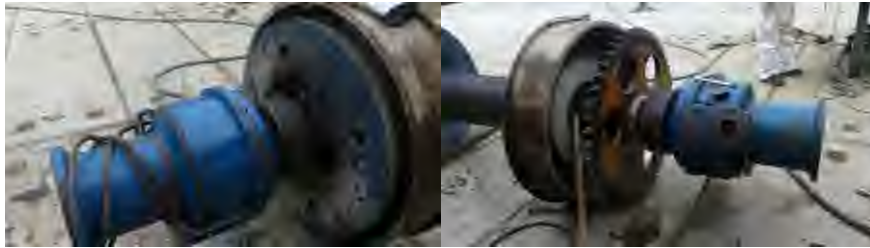
- d. Checked the bearings clearance on cathead shaft. Clearance found out of tolerance (1.05mm DS – 0.65mm ODS) advise to replace them

Update 20/02/2019: bearing replaced with new

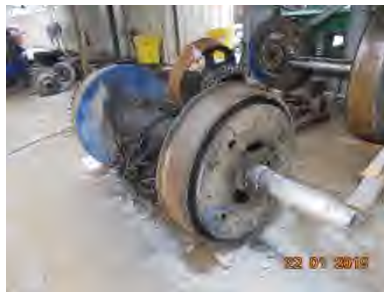
- e. Cathead shaft already dismantled to remove the worn bearings

- f. Cathead shaft NDT inspected (fluorescent) and no relevant indication found

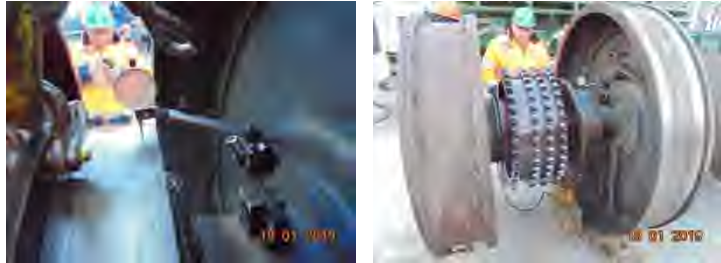
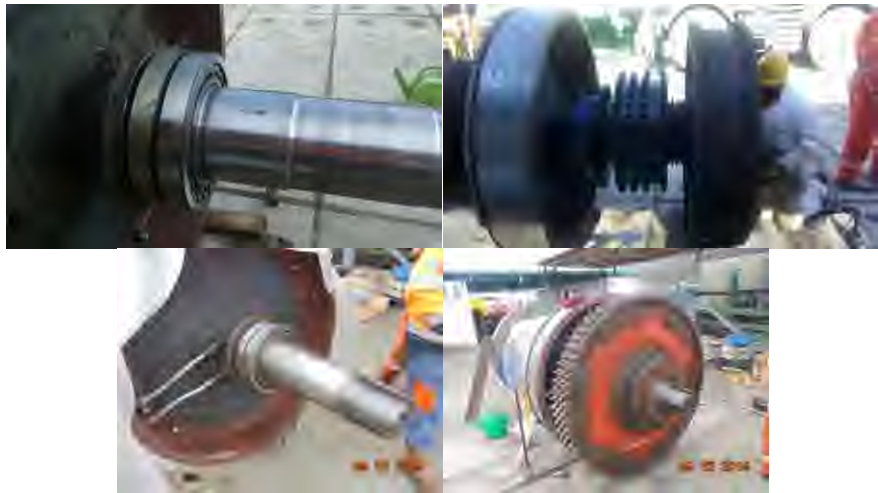
- g. Checked the bearings clearance on main drum shaft. Clearance found out of tolerance. Advise to replace bearings

Update 20/02/2019: bearing replaced with new

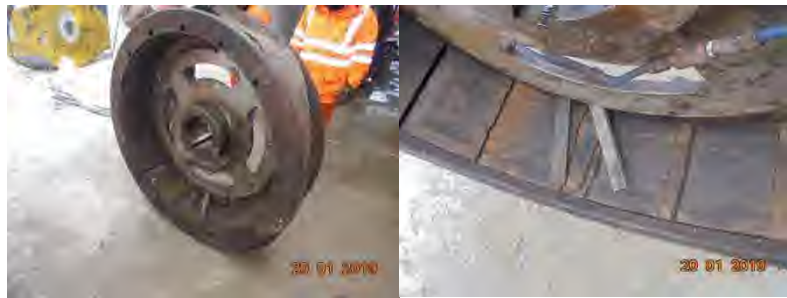
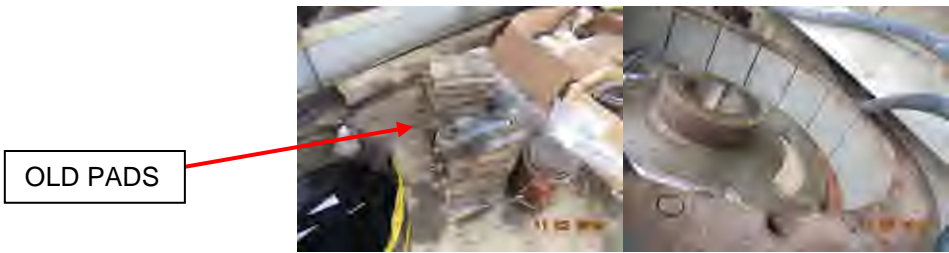
- h. High speed clutch removed and found with some broken pads. Replace all the pad

Update 20/02/2019: all pads replaced with new

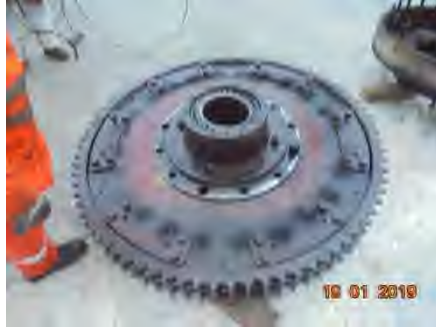
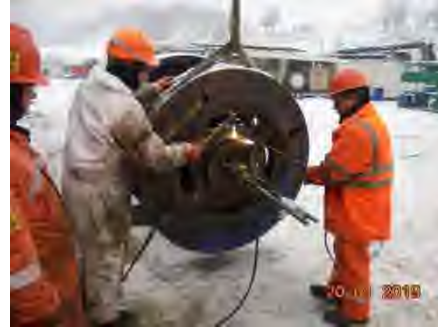
- i. Main drum shaft dismantled for remove the worn bearings. During dismantle was necessary to heat with heating torch the outer bearings of the two sprockets. Those bearings need to be replaced

Update 20/02/2019: bearing replaced with new.

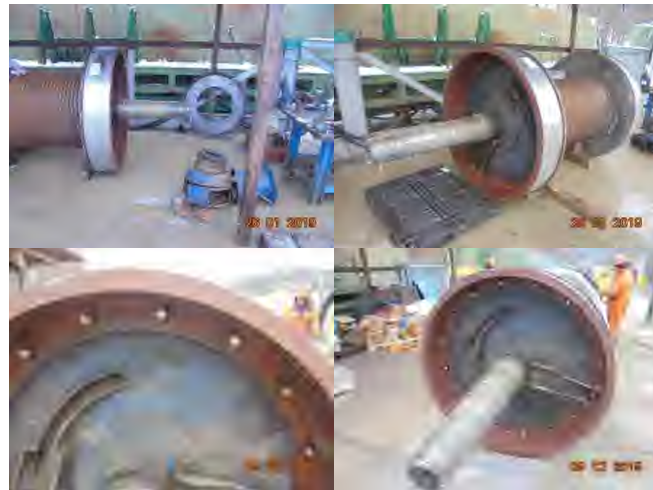
- j. Old Brake rims removed for replacing. New rims already presents on site to be installed

Update 27/01/2019: new brake rims already installed but with temporary 4 bolts each, waiting for new bolts as mentioned on 6.k

Update 20/02/2019: temporary bolts removed. New bolts installed along with new nuts and new safety pins

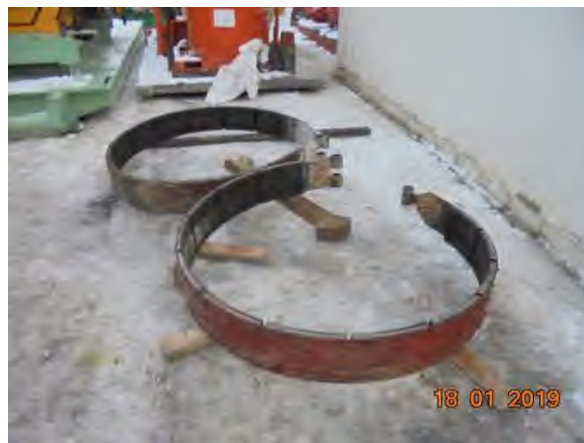
- m. Advise to replace the brake pad on band brakes. At least, the old ones need to be cleaned for some grease/oil deposit with a detergent solution suitable for the job

Update 20/02/2019: brake bands replaced with new.

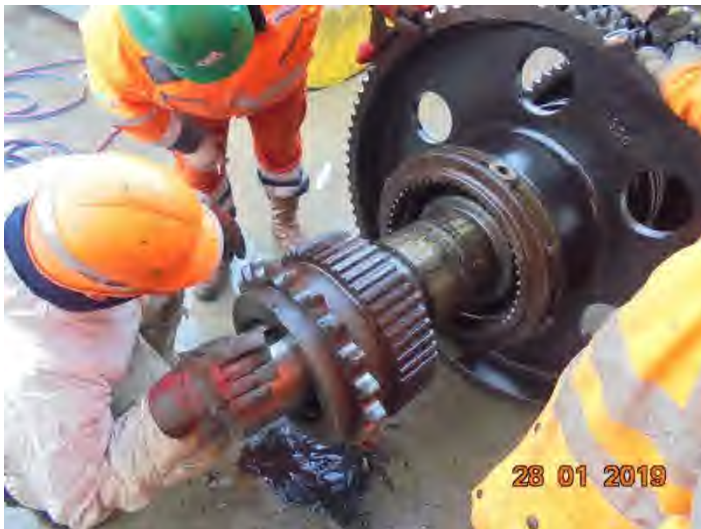
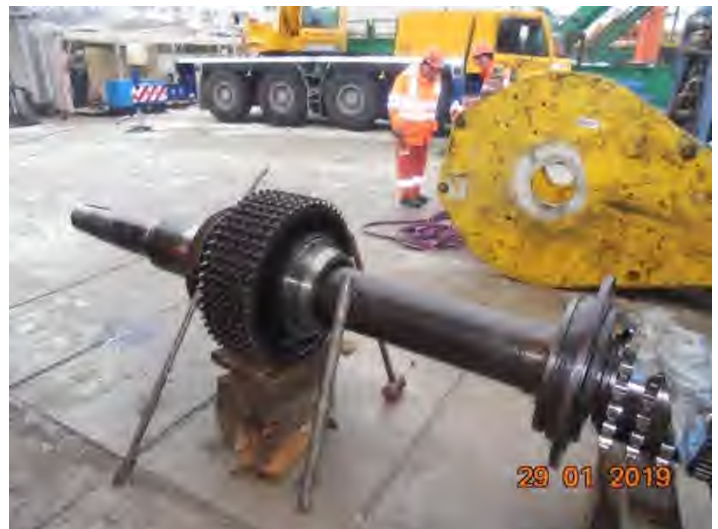
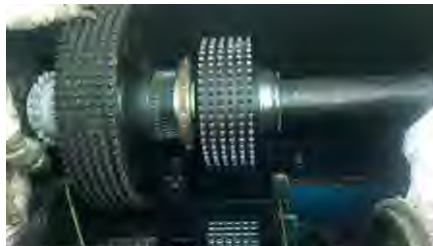
- p. started to dismount the power input shaft due to sprocket replacement

Update 20/02/2019: sprocket replaced. All power input shaft assy reassembled and installed back on drawwork frame

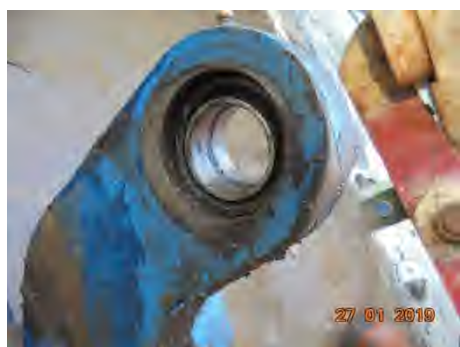
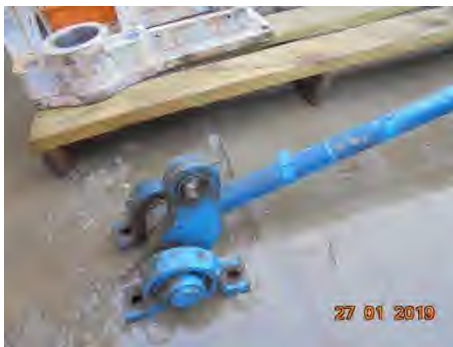
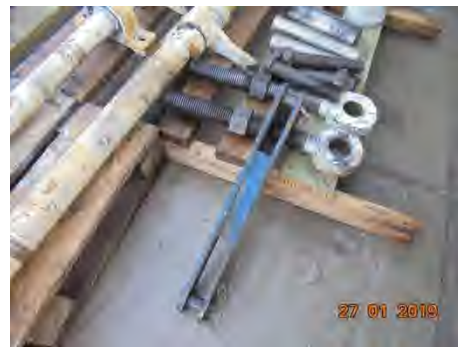
- p. Found driller brake lever with excessive play. Need to be restored. Fabrication of new pins (on going) and new bushings

Update 30/01/2019: pins already fabricated

Update 20/02/2019: new bushing fabricate and installed. Alignment of brake lever mechanism already done on drawwork frame

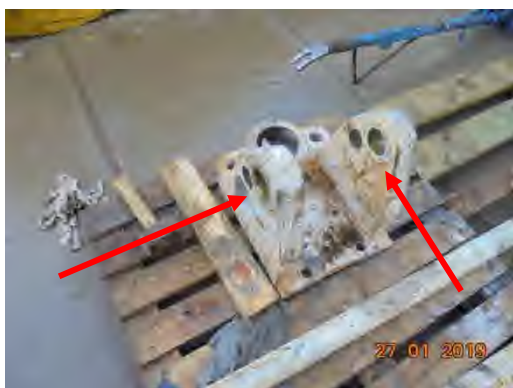
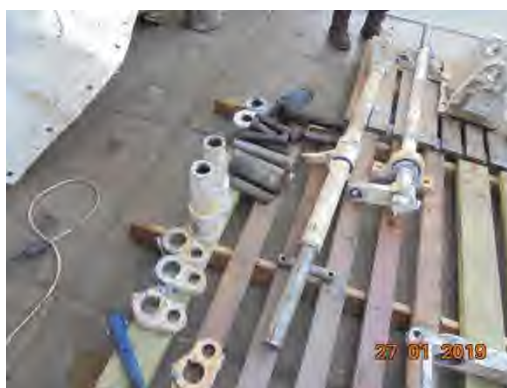
- q. Funded brake lever supports with bushings worn by foreign materials. Advise to replace

Update 20/02/2019: bushings replaced with new
