<b>Specialist Oilfield Services K.S.C</b>				<b>SOS / QA / 10</b>			
<b>INSPECTION REPORT</b>									
<b>Job Number</b>		JO-25-387				<b>Report Number</b>		JO-25-387-2-01	
<b>Item Detail</b>		37-1/2" Rotary Table				<b>Inspection Date</b>		11/05/2025	
<b>Traceability</b>		SN# 122				<b>Procedure ref.</b>		QIP-45 issue 01 Rev 04..	
<b>Customer</b>		IRE				<b>Acceptance STD</b>		--	
<b>Inspection Stage</b>									
As received	After blasting / cleaning	After Pre-machining / proof machining	After welding	After final machining	After heat treatment	Prior assembly	After testing	After painting / coating	Final Inspection
<b>Inspection Details</b>

Job Number	JO-25-387	Report Number	JO-25-387-2-01
Item Detail	37-1/2" Rotary Table	Inspection Date	11/05/2025
Traceability	SN# 122	Procedure ref.	QIP-45 issue 01 Rev 04..
Customer	IRE	Acceptance STD	--

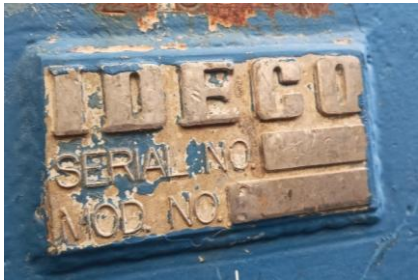
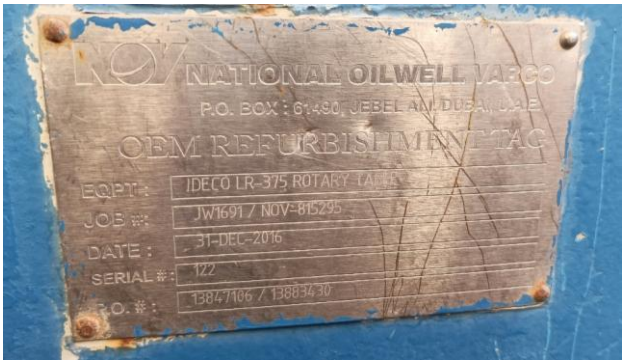
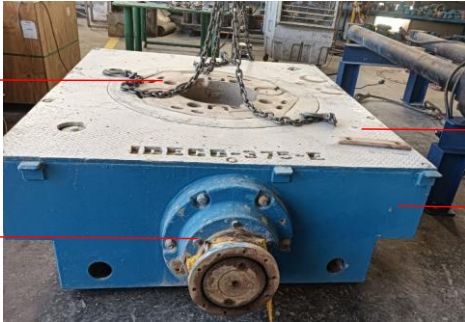
#	Part Detail	Observation					Recommendation / Remark		
1	37-1/2" Rotary Table Make : IDECO  <b>SN# 122</b>	# Main body (SN: 122) external surface visually found ok #Master Bushing (SN: 310116) - lock pin found stuck (Qty-2 nos) # Pinion Hub (SN: N/A) : external surface visually found OK # Cover Plate (SN: Ideco-375-E): external surface visually found ok					# Subjected to client		
<b>NOTE:</b> N/A : NOT AVAILABLE / APPLICABLE									
<b>PICTURES / SKETCH / DRAWING REFERENCE</b>									
<div style="display: flex; justify-content: space-around;">

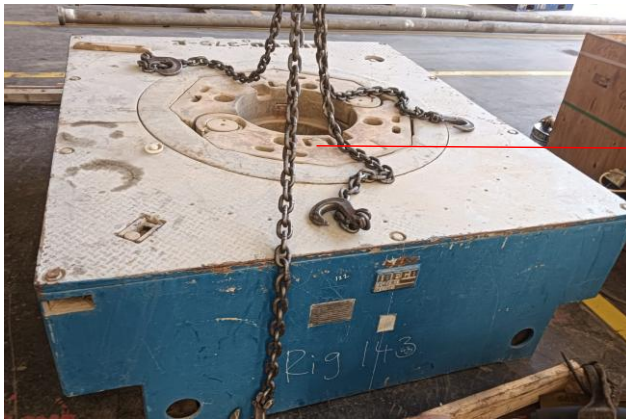
Master bushing lock pin stuck
