Specialist Oilfield Services (SOS) were requested by to carry out a CAT IV on the 37.5 IDECO Rotary Table, Serial No122 for their Client IR&E. This work was conducted under Job No: JO-25-387

| | <b>Our Scope:</b> Inspection & Re-Certification of Rotary Table. | | |
| <b>Equipment</b> | IDECO LR-37.5 Rotary Table | <b>Revision#</b> | 0 |

| Scope of Work | Cat IV Overhaul | | |

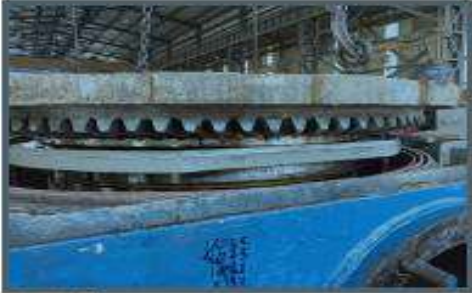
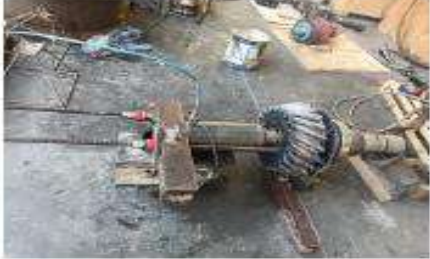
| 1 | IDECO LR-37.5 Rotary Table<br>Make : IDECO<br>SN# 122 | # Dismantling of parts on going | | # Subjected to client | |

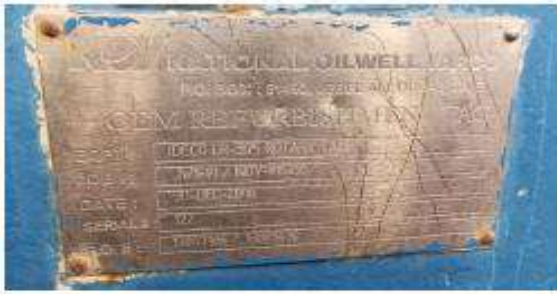
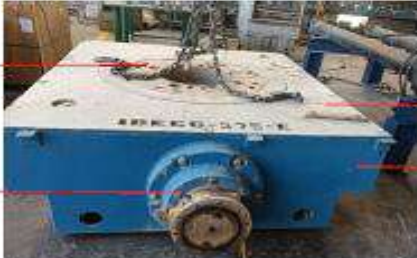
| <b>Customer</b> | | IR&E | | <b>Acceptance STD</b> | |
| | | | | - | |
| 1 | IDECO LR-37.5<br>Rotary Table<br>Make : IDECO<br><br>SN# 122 | # Main body (SN: 122) external surface visually<br>found ok<br>#Master Bushing (SN: 310116) - <b>lock pin found<br/>stuck (Qty-2 nos)</b><br># Pinion Hub (SN: N/A) : external surface visually<br>found OK<br># Cover Plate (SN: Ideco-375-E): external surface<br>visually found ok | # Subjected to client | | |
| <div style="display: flex; justify-content: space-around;"> </div> <div style="display: flex; justify-content: space-around; margin-top: 20px;"> <div style="text-align: center;"> <div style="position: absolute; left: 10px; top: 10px; border: 1px solid black; padding: 2px;">Master Bushing</div> <div style="position: absolute; left: 10px; top: 40px; border: 1px solid black; padding: 2px;">Pinion Hub</div> <div style="position: absolute; left: 60px; top: 10px; border: 1px solid black; padding: 2px;">Cover plate</div> <div style="position: absolute; left: 60px; top: 40px; border: 1px solid black; padding: 2px;">Main Body</div> </div> </div> | | | | | |

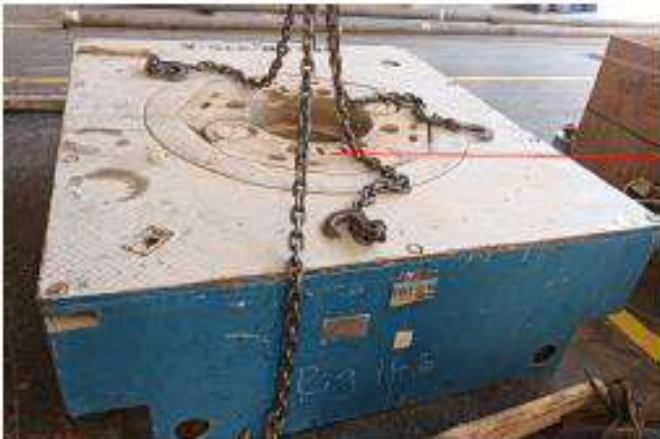
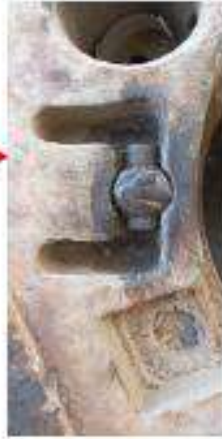
| <p>Master bushing lock pin stuck</p> <div style="display: flex; justify-content: space-around; align-items: center;"> </div> | | | | | |

After inspection review customer decided Master Bushing not required to be repaired.

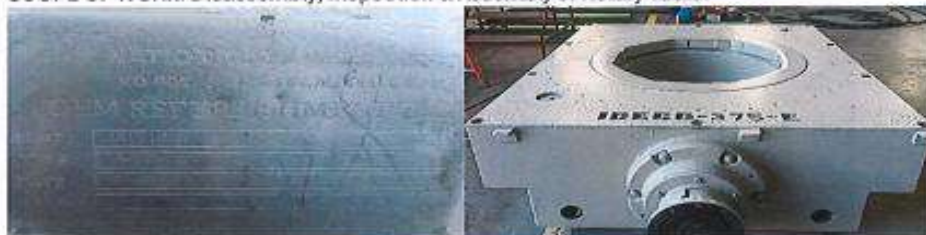
**Finding**

Found multiple crack indications on the Base (P/N 308-123), weld repair done as per WPS.

Visually inspected the bull Gear. Moderate pitting found.

Checked the gear backlash. Found to be 0.025" at some areas, which is below the allowable range.

- Rotary table 37 1/2" was received SOS facility on May10,2025 for category IV inspection & overhaul. The assembly was dismantled, inspection performed, repaired & re-painted as per OEM specifications & procedures.
- All the new bearings & seals as per OEM recommendations.
- All the bearings were installed with new grease before assembly.

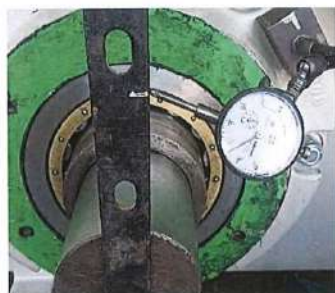
**FINAL BACKLASH (BETWEEN PINION GEAR TO RING GEAR)**

- Filled the RT with oil & checked the Rotation Manually.
- No leakage or abnormal sound was observed.

- Fill the RT with oil, Prior to testing with motor @ RIGSITE.

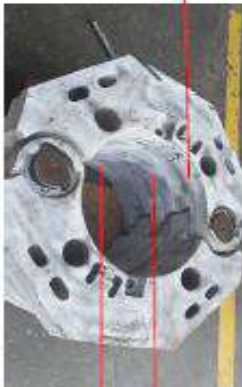
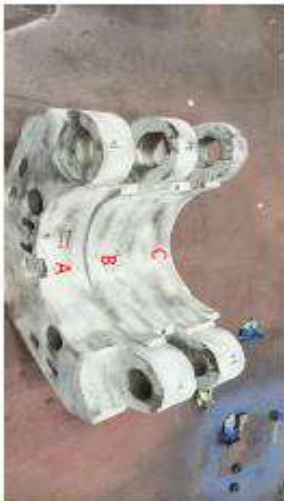
| SOS | | | | | | | | | | DIMENSIONAL INSPECTION REPORT | | | | | | | | | | SOS / QA / 02 | |
|---|---|---|---|---|---|---|---|---|---|---|--|---|--|--|--|--|--|--|--|---|--|
| # | Item / Component / Part Description | Serial No. / Part No. | Location | Actual Dimension | | | | Visual condition | Status | Recommendation | | | | | | | | | | | |
| | | | C | 19.107 | 19.063 | 19.105 | 19.106 | | | | | | | | | | | | | | |

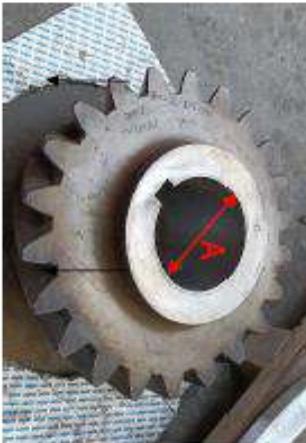
| SOS | | | | | | | DIMENSIONAL INSPECTION REPORT | | | | SOS / QA / 02 | |
|---|---|---|---|---|---|---|---|---|---|--|---|--|
| 1 | Pinion Gear ID | PIN# 308-85-02 | A | 5.745 | 5.747 | 5.747 | - | - | - | | | |

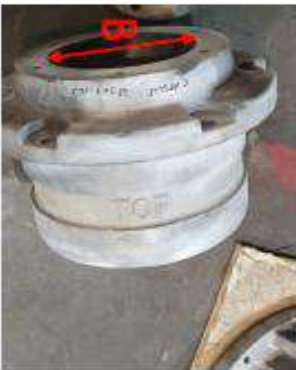
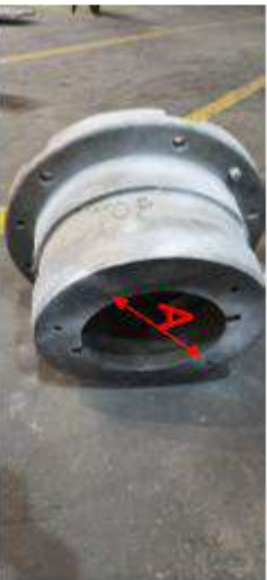
| SOS | | | | | | | | | | DIMENSIONAL INSPECTION REPORT | | | | | | | | | | SOS / QA / 02 | |
|---|---|---|---|---|---|---|---|---|---|---|---|--|---|--|--|--|--|--|--|---|--|
| Client: | | IR&E | | | Report No.: JO-25-387-4-07 | | Instrument used CAL/SOS/IM/008 | | | | | | <input checked="" type="checkbox"/> As received<br><input type="checkbox"/> Inprocess Inspection<br><input type="checkbox"/> Final Inspection | | | | | | | | |
| | | | B | | | 11.017 | 11.022 | 11.019 | - | - | - | | | | | | | | | | |

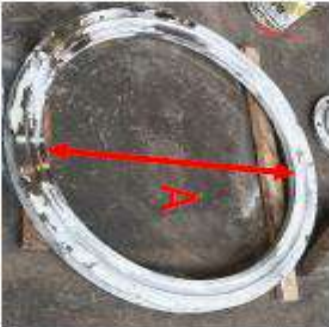
| SOS | | | | | | | | | | DIMENSIONAL INSPECTION REPORT | | | | | | | | | | SOS / QA / 02 | |
|---|---|---|---|---|---|---|---|---|---|---|--|---|---|--|---|--|--|--|--|---|--|
| 1 | Main bearing Assembly<br>Middle Riser ID | PN# 308-95-02 | A | 41.056 | 41.051 | 41.053 | - | - | | | | | | | | | | | | | |

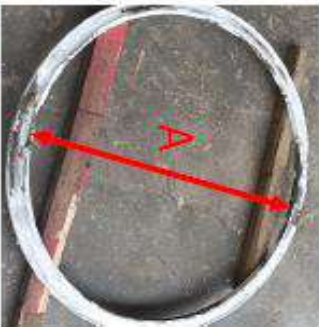
| SOS | | | | | | | | | | DIMENSIONAL INSPECTION REPORT | | | | | | | | | | SOS / QA / 02 | |
|---|---|---|---|---|---|---|---|---|---|---|--|--|--|---|--|--|--|--|--|---|--|
| 1 | Main bearing Assembly<br>Upper Riser ID | PN# 308-96-01 | A | 41.007 | 41.008 | 41.008 | - | - | - | | | | | | | | | | | | |
