Completion Report

7838 – BRAKE OVERHAUL REPORT

Customer	International Rig & Equipment	Job No	W-24154
Date Received	22.03.2024	Purchase Order No	TS/612/798 REV-1
Quotation No	DWQ 30013	Start Date	13.05.2024
IRE stock number	0414-0-001	Completion Date	02.07.2024

Brake Nameplate Data			
Serial No	RHZ 11052W	Model	Baylor 7838 W
Assembly No	R/B 31591	Input Amps	74
Maximum RPM	600	Input Volts	250 VDC
Coolant	Water	Flow Rate	150

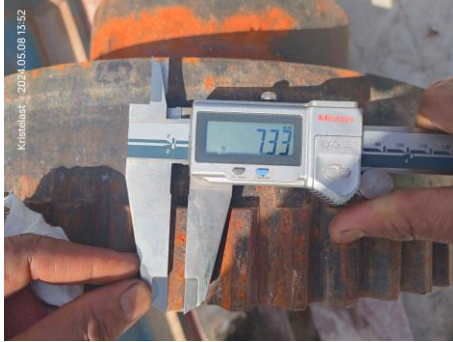
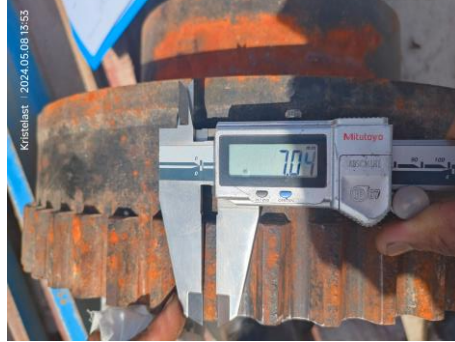
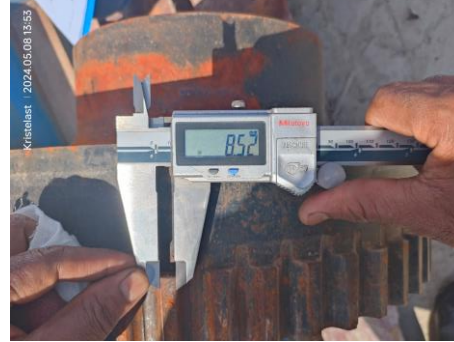
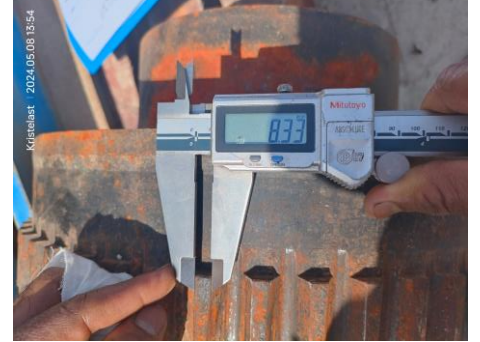
HUB WEAR AND TEAR MARKS

Inspection Report Summary		Job №	W-24154
Sr. №	Observations (After Dismantling)		
1	All parts are good.		
2	Both magnets hydro tested ok.		
3	Both the side bearing housings and shaft bearing journals are in tolerance.		
4	Both the side bearings need to be replaced.		
5	All 4 no's of Seals need to be changed.		
6	DE side drum ID has ovality, need to machine.		
7	Both the side seal sleeves are good.		
8	NDE Side Drum ID Surface has deep Groove marks.		
9	Customer Supplied brake HUB the condition of the HUB found Good, Report Attached.

FRONT TEETH

7.33 mm

7.04 mm

BACK TEETH

8.52 mm

8.33 mm

Sr. №	Proposed Scope of Work
1	Clean all the parts.
2	MPI the rotor shaft.
3	Machine Rotor drum both the sides, Skim cut to remove ovality.
4	Weld and Machine both magnets to suit proper air gaps.
5	Replace both the bearings, seals, Breathers, Grease hose and fittings.
6	Recommend to replace DE Hub (HUB Supplied by the Customer)
7	Assemble, polarity and airgap test.
8	Record readings.
9	Paint and dispatch.

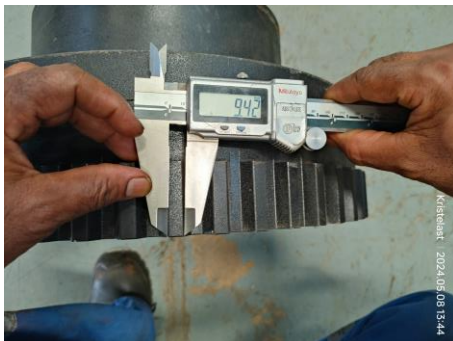
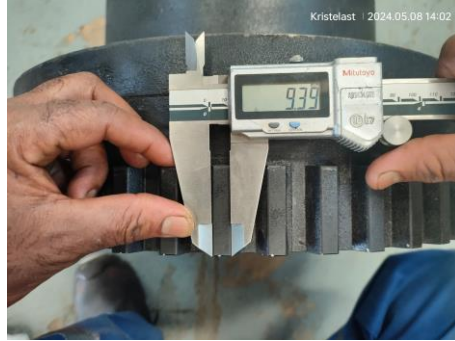
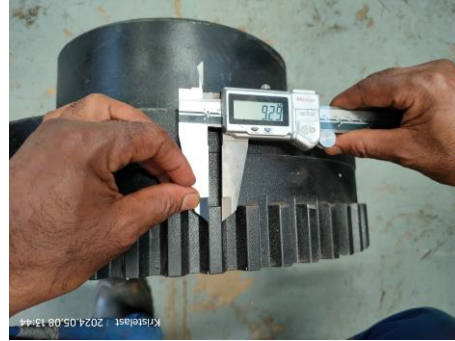
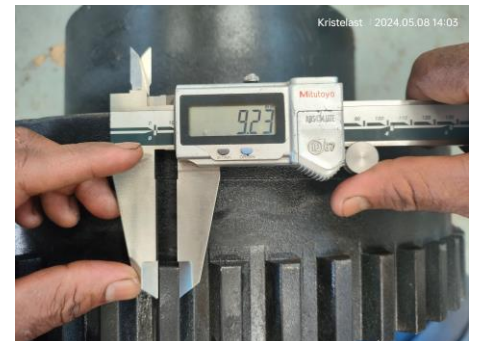
NEW HUB

FRONT TEETH

9.42 mm

9.39 mm

BACK TEETH

9.29 mm

9.23 mm

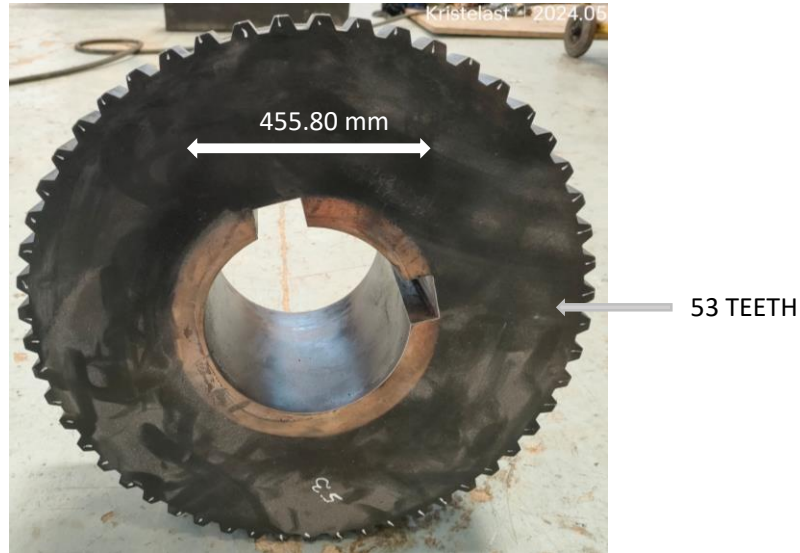
Inside Taper Hub Bore Measurements

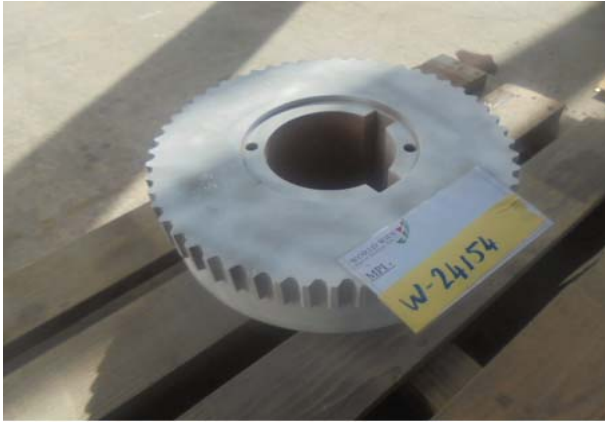
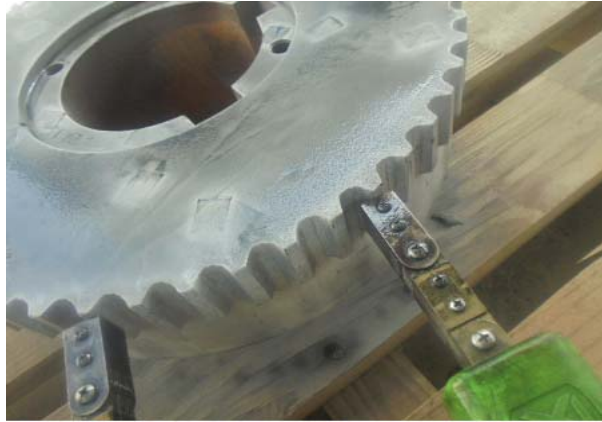
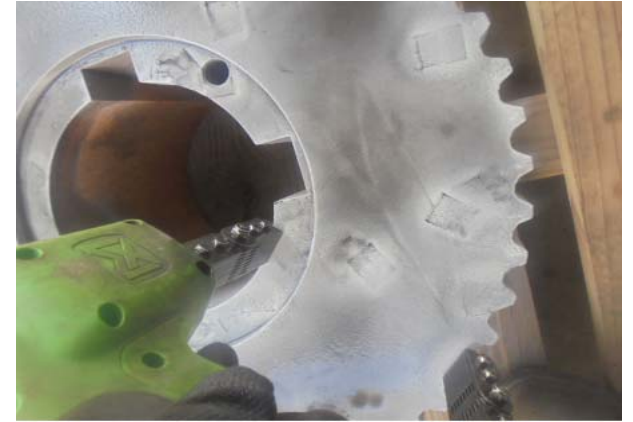
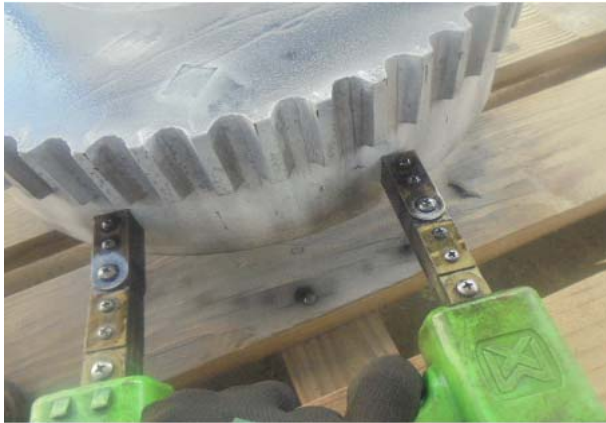
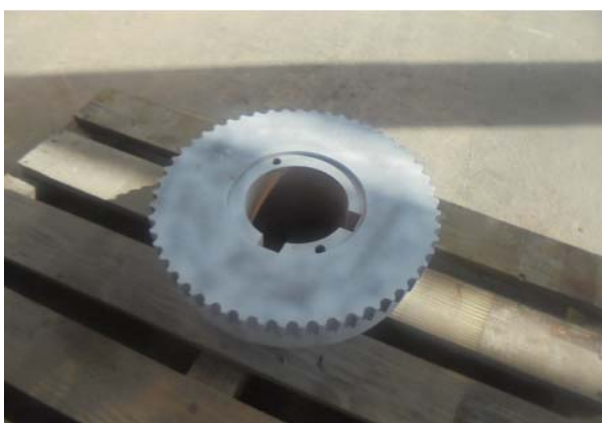
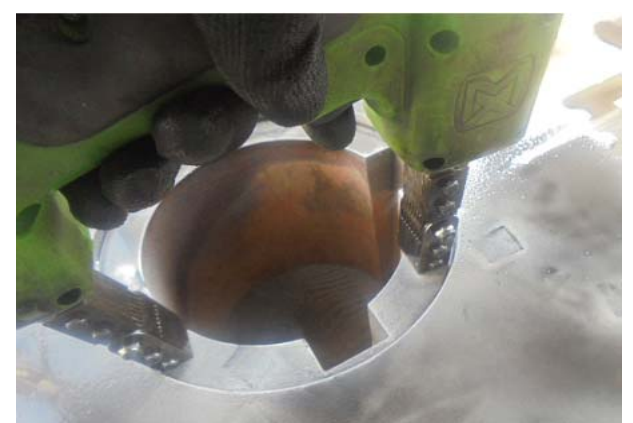
MPI IMAGES

Procedure Reference : QP-WS-07
 Material Condition : Dismantle
 Surface Condition : Machined
 Lighting Source & Intensity : Daylight above 1076 Lux
 Material temperature : 34°C
 Particle Application : By spray
 Acceptance Criteria : Section II of QP-WS-07, Issue 3, Rev. 1
 Post-Cleaning : Using thinner
 Demagnetization : N/A
 Observation : No relevant indication was observed during the test
 Examination Result : As below
 Accepted Defect Noticed Recommend to attached sketch

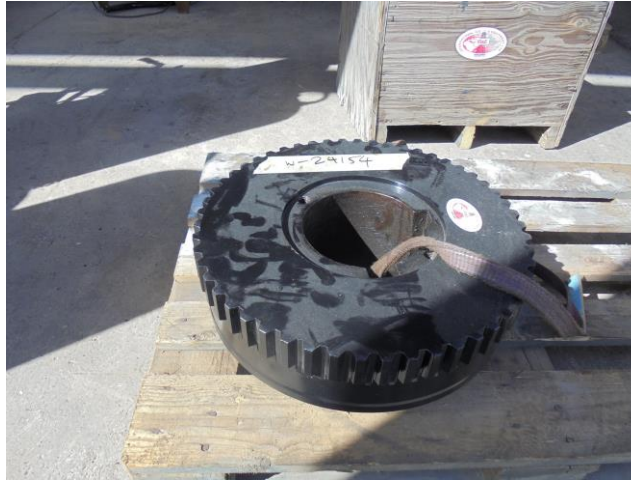
Brake HUB Supplied by the Customer

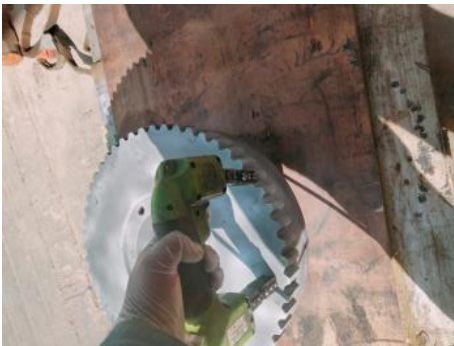
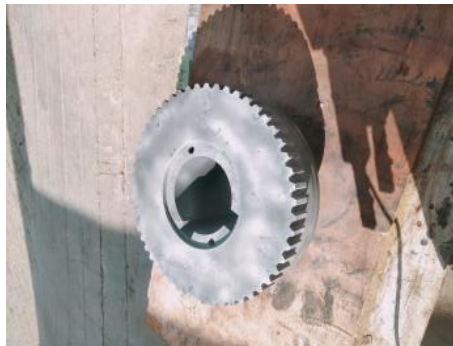
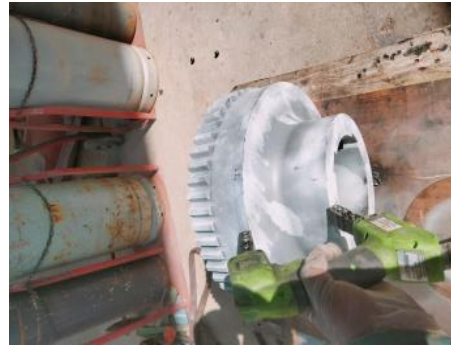
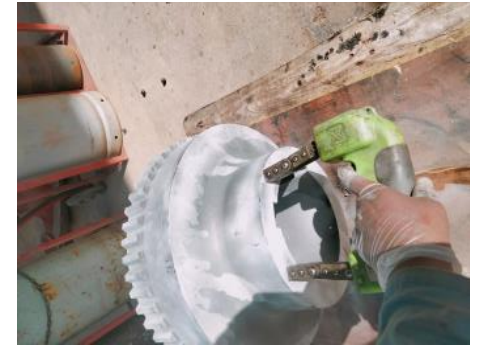
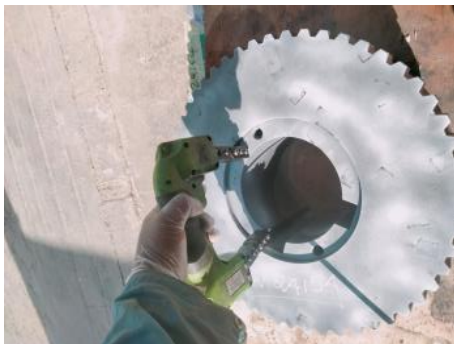
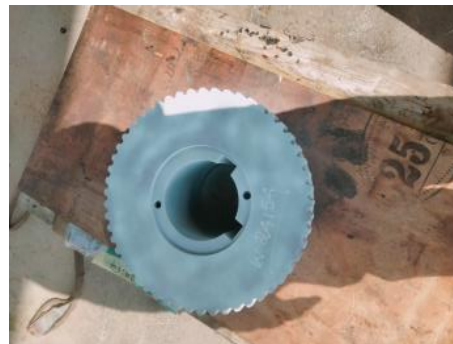
MPI TEST

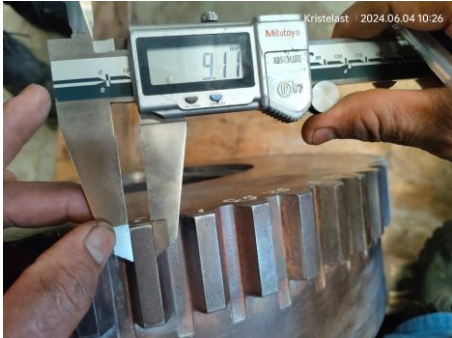
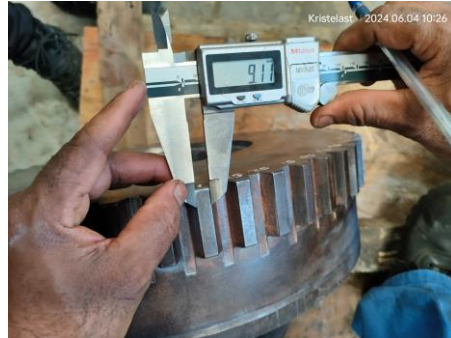
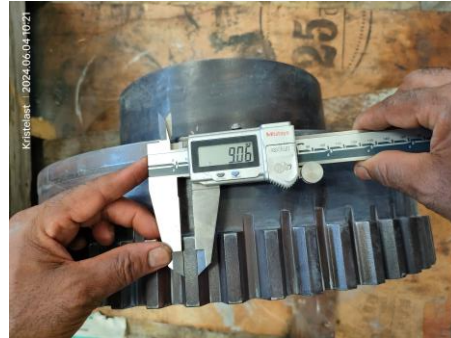
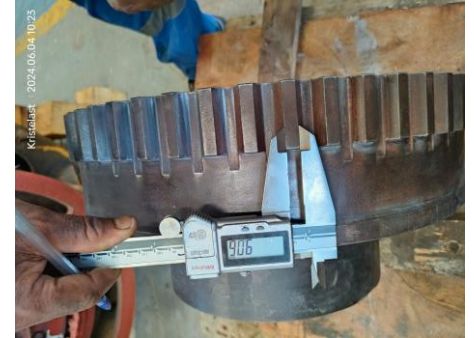
HUB Supplied By The Customer

FRONT TEETH

9.11 mm 9.11 mm

BACK TEETH

9.06 mm 9.06 mm

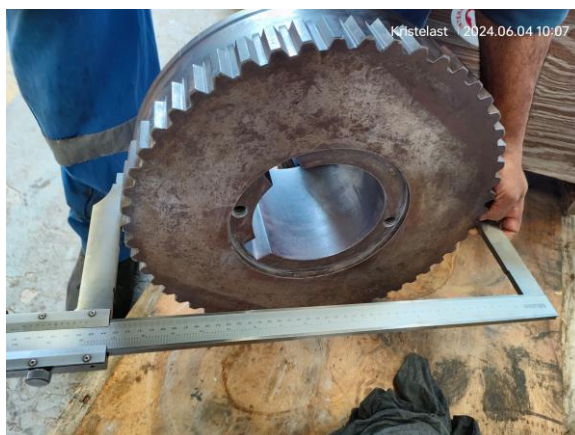
Inside Taper Shaft Diameter

455.80 mm

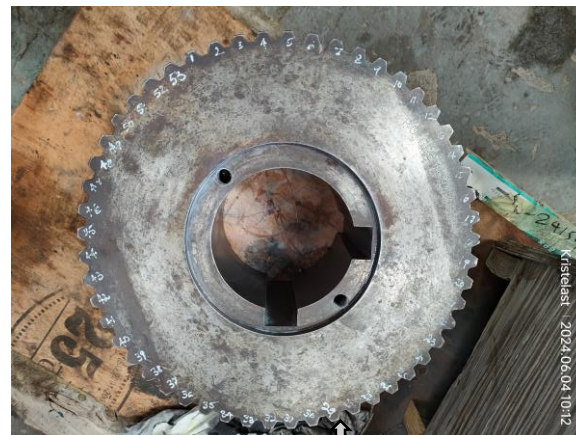
53 TEETH

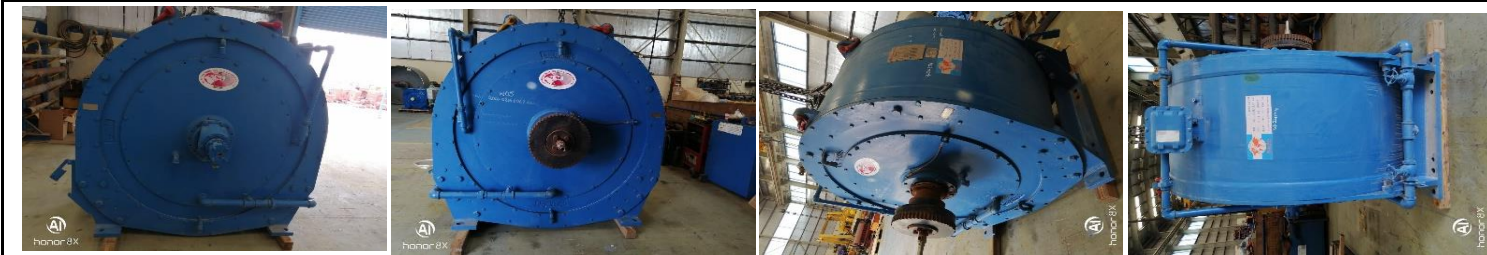
Received Brake

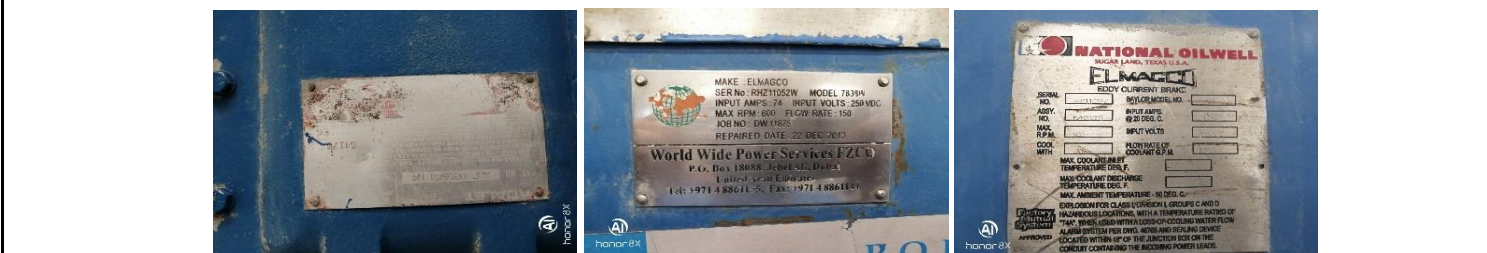
Name Plate Details

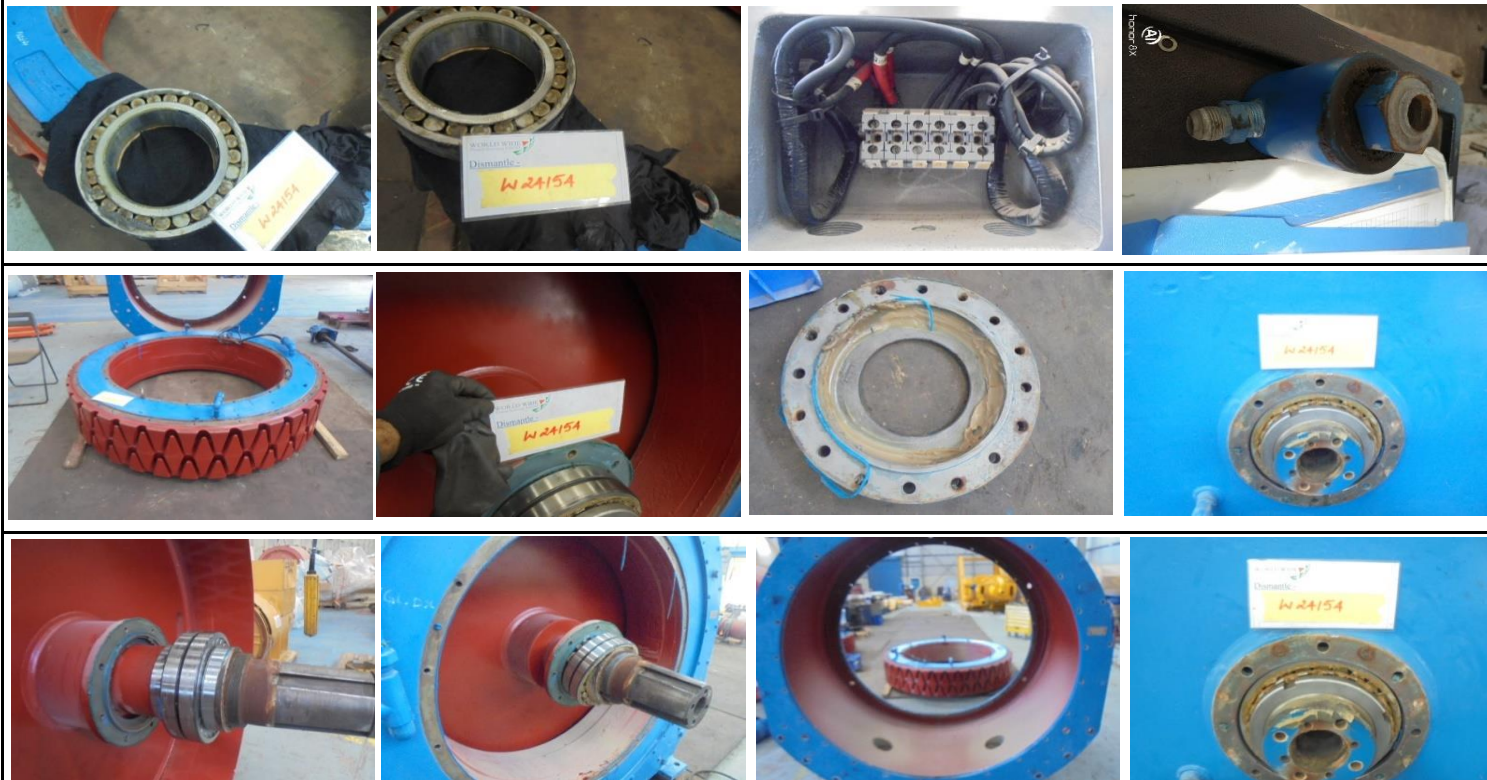
Dismantle / Damaged / Rusted Parts

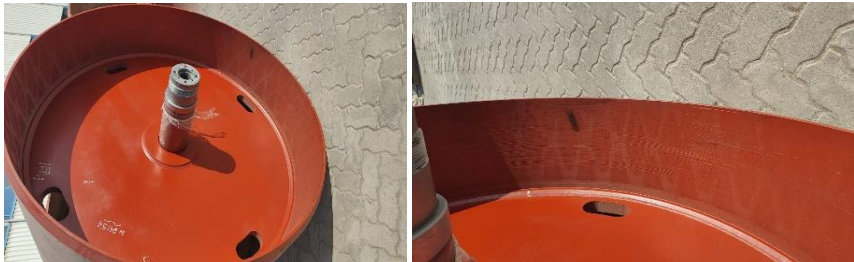
NDE SIDE DRUM (Deep line marks)

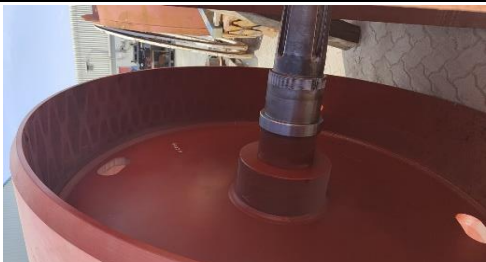
DE SIDE DRUM (Ovality)

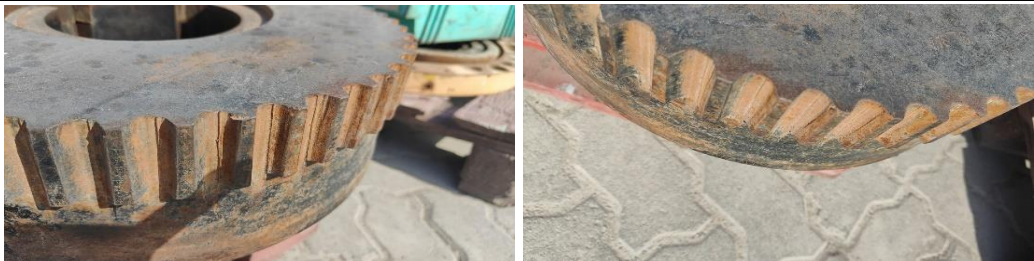
HUB TEETH (Wear & Tear Marks)

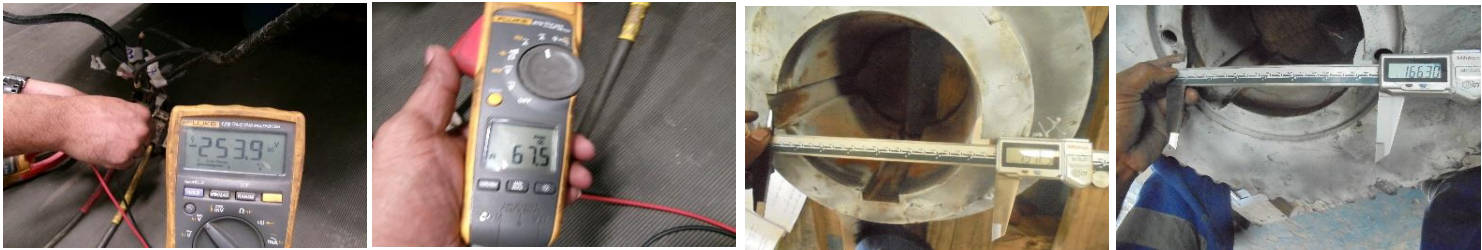
Other Tests

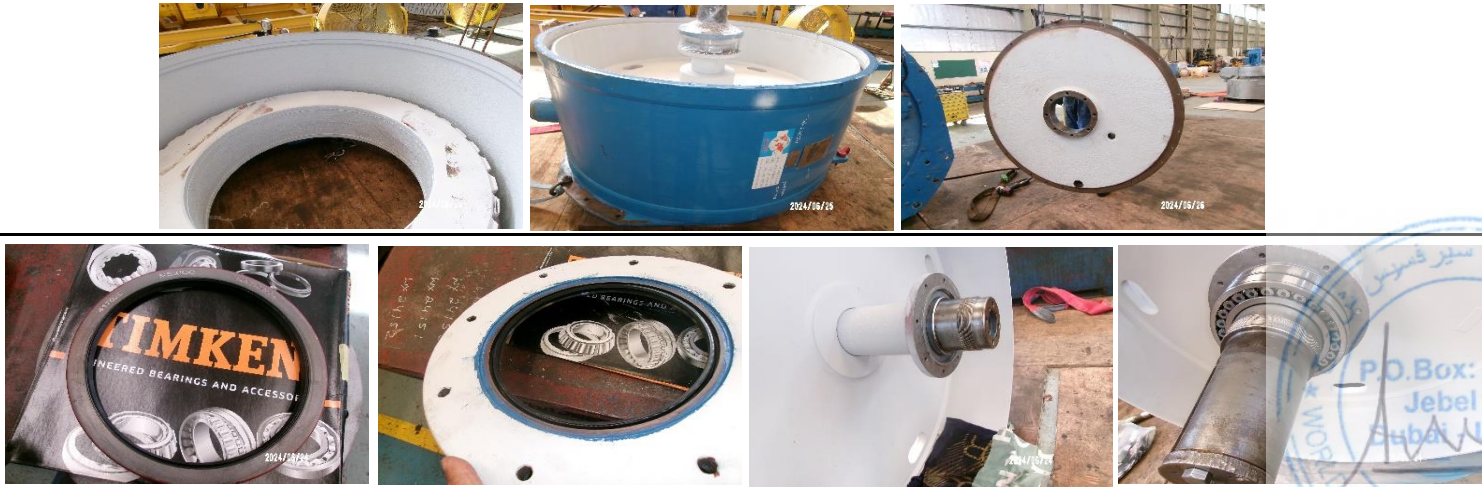
Assemble

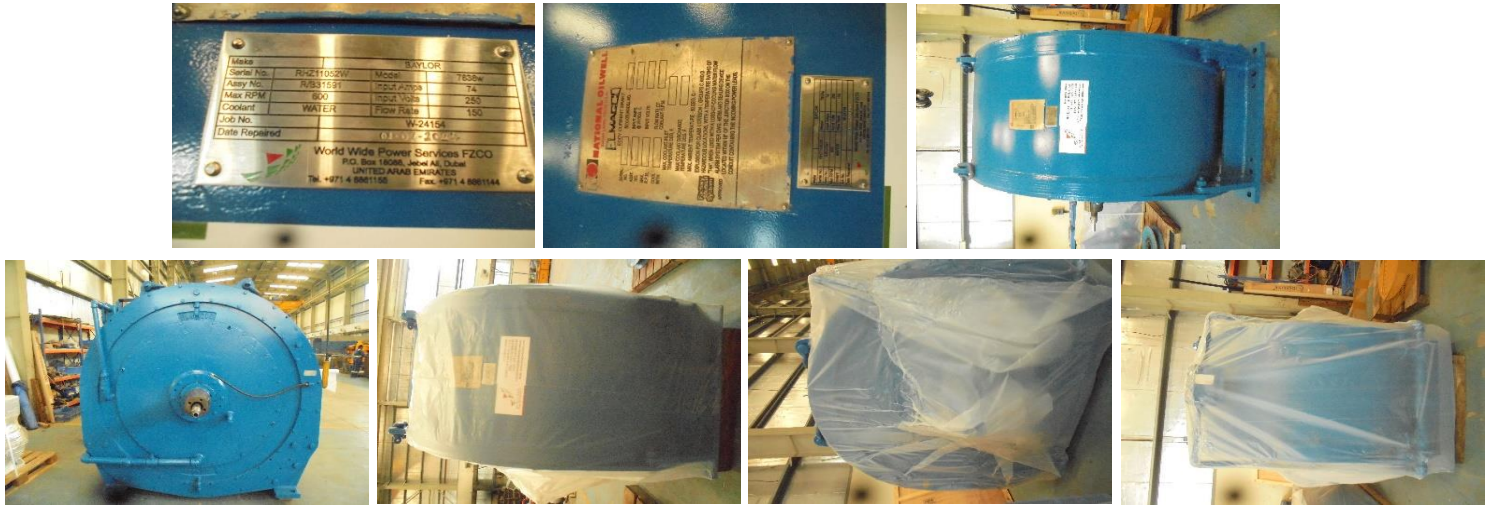
Labeling & Final packing before dispatch
